## CONDITION REPORT

Report No:  
2017287377  
DATE  
20/08/2026

| Manufacturer | VOLKSWAGEN | Registration Number | JX57BDGP |
| Model | POLO VIVO 1.4 55KW TRENDLINE 5-DR [2020-2022] | Register Number | |

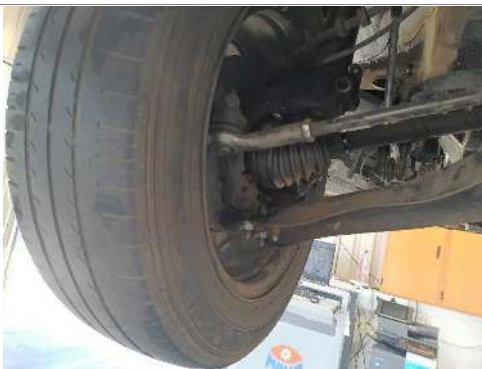
LF TYRE TREAD

| | Size | Load/Speed Index | Manufacture | Model | Type* | Production Date | Tread Depth (mm) |
|---|---|---|---|---|---|---|---|
| Front Left | 175/65R15 | 84H | Kumho | Solus | V | 2314 | 1 mm |

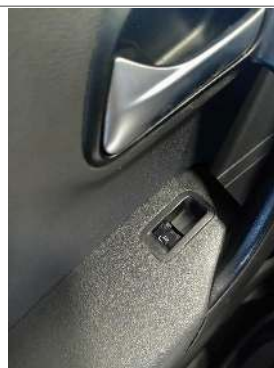
| Damage | Repair Way |
|---|---|
| Switch Electrical Window Winder front left Defective | Repair |

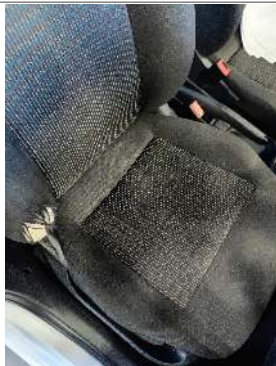
| Damage | Repair Way |
|---|---|
| Seat Front Right Torn / Cut | Repair |

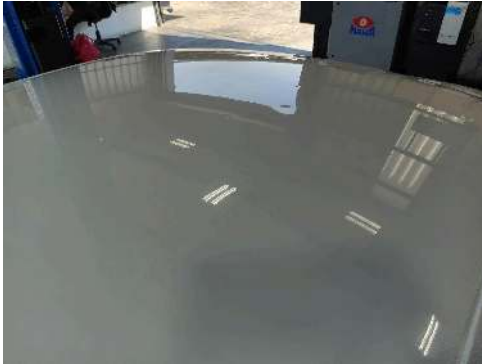
| Damage | Repair Way |
|---|---|
| Roof Dented | Repair |

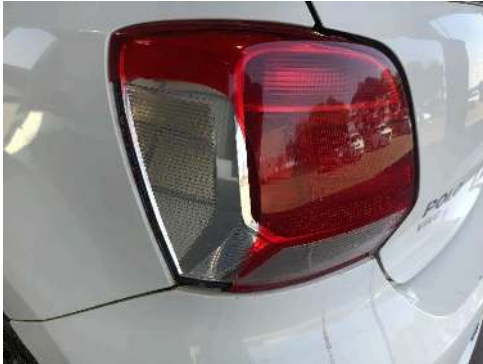
| Damage | Repair Way |
|---|---|
| Tail Light Left Damaged | Replace |

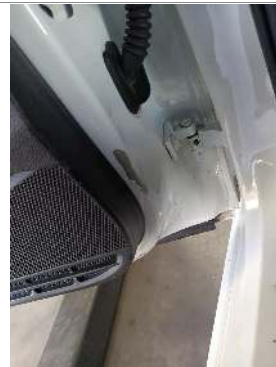
| Damage | Repair Way |
|---|---|
| Door Rear Left Paintwork • Scratched | Repair |

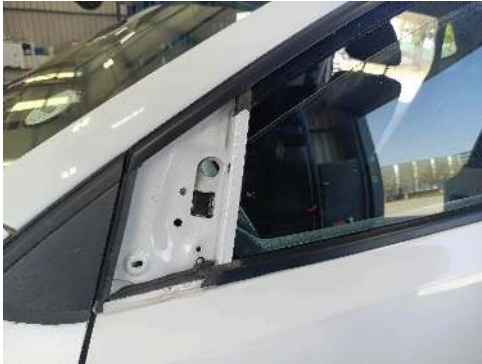
| Damage | Repair Way |
|---|---|
| Side Mirror Left Damaged | Replace |

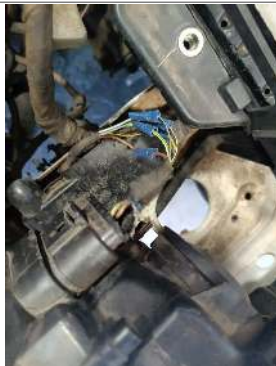
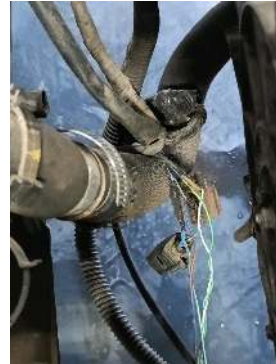
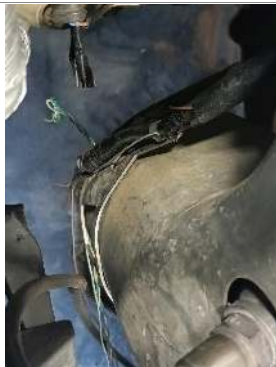
| Damage | Repair Way |
|---|---|
| Engine Wiring Defective | Repair |

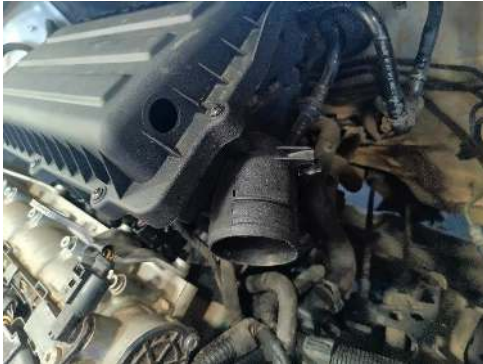
| Damage | Repair Way |
|---|---|
| Air cleaner Defective | Repair |

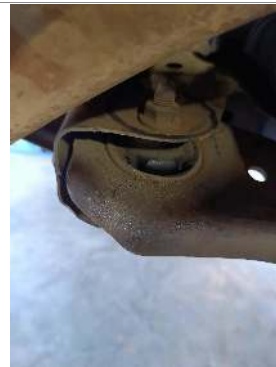
| Damage | Repair Way |
|---|---|
| Control Arm Bush(es) Front Axle Right Cracked | Replace |

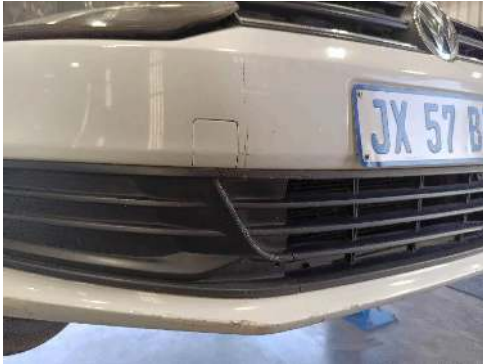
| Damage | Repair Way |
|---|---|
| Front Bumper Paintwork • Scratched | Repair |

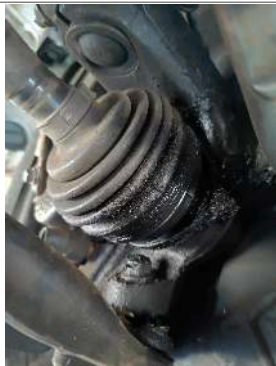
| Damage | Repair Way |
|---|---|
| CV Joint(s) Boot(s) Front Right (inner/outer) Damaged | Replace |
| both front CV joints excessive noise | Replace |

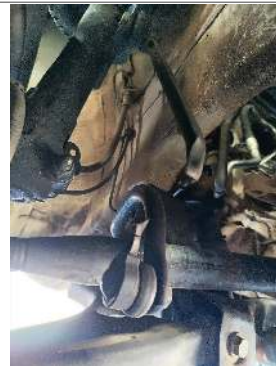
| Damage | Repair Way |
|---|---|
| Stabilizer Mounting Front Right Damaged | Replace |

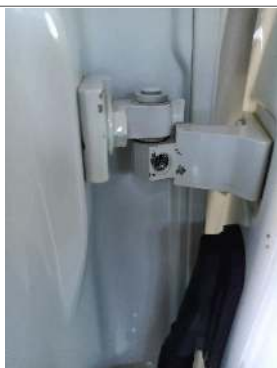
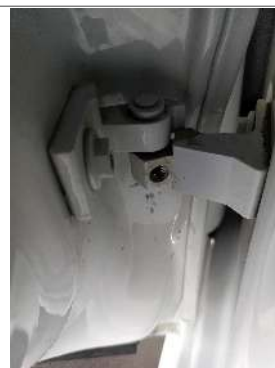
| Damage | Repair Way |
|---|---|
| Door Hinges Rear Left Defective | Replace |

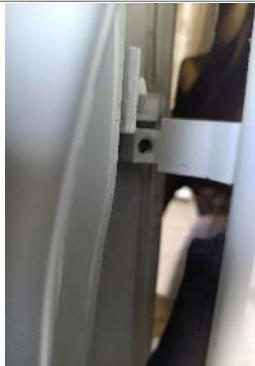
| Damage | Repair Way |
|---|---|
| Door Hinges Front Left Defective | Replace |
