CONDITION REPORT

Report No:  
2017296263  
DATE  
09/09/2026

| Manufacturer | TOYOTA | Registration Number | HFG367L |
| Model | HI-ACE 2.5 SESFIKILE 16-S DSL MINIBUS [2021-2024] | Register Number | |

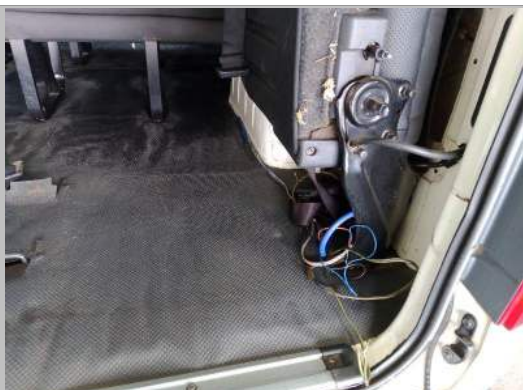
| Damage | Repair Way |
|---|---|
| Loose wiring on undercarriage | Repair |

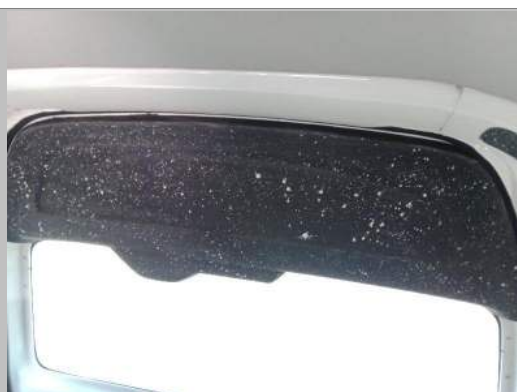
| Damage | Repair Way |
|---|---|
| Interior boot panel damaged | Repair |

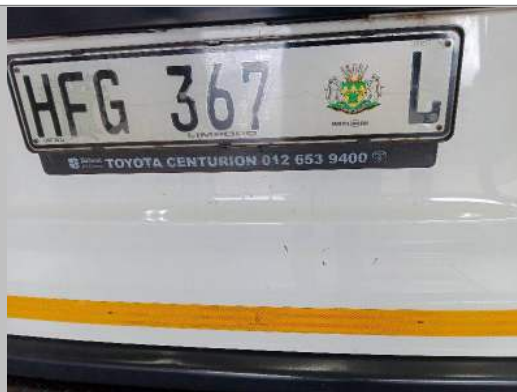
| Boot Lid / Hatch door Paintwork • Scratched | Repair |

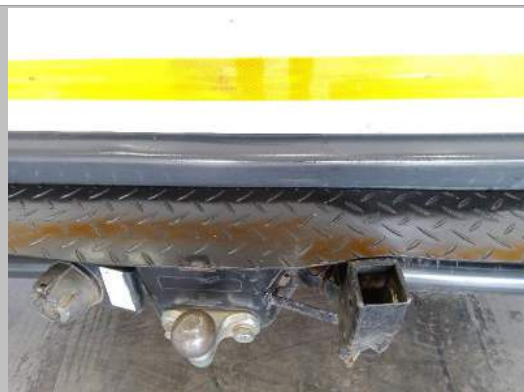
| Rear bumper Damaged | Repair |

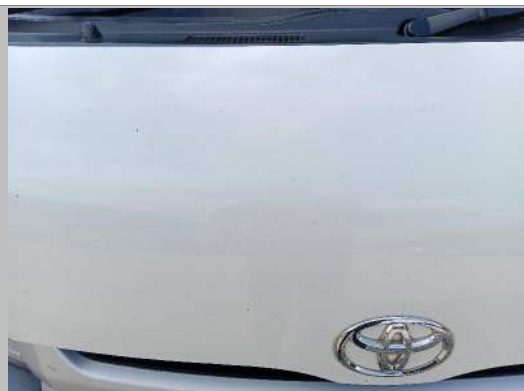
| Bonnet Paintwork • Chipmarks | Repair |

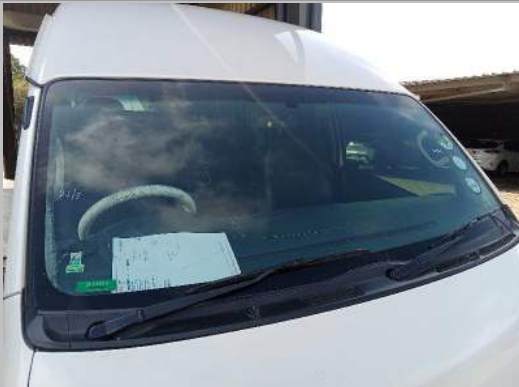
| Windscreen Cracked | Replace |

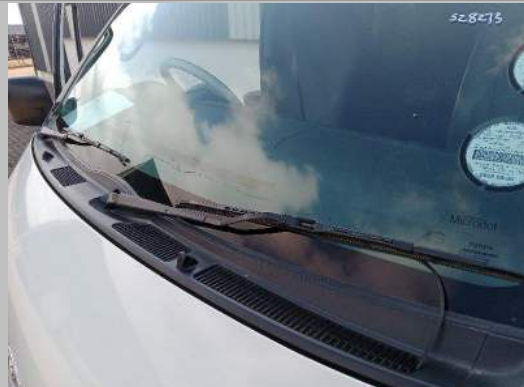
| Windscreen Wiper Damaged | Replace |

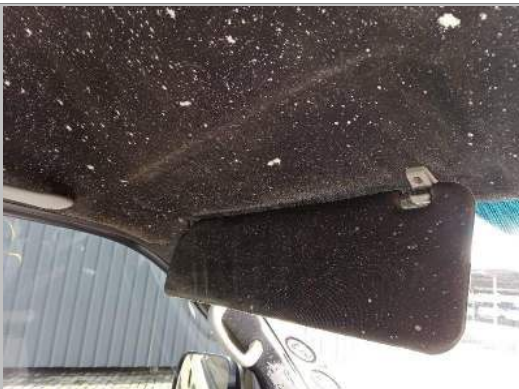
| Sun Visor Left Damaged | Replace |

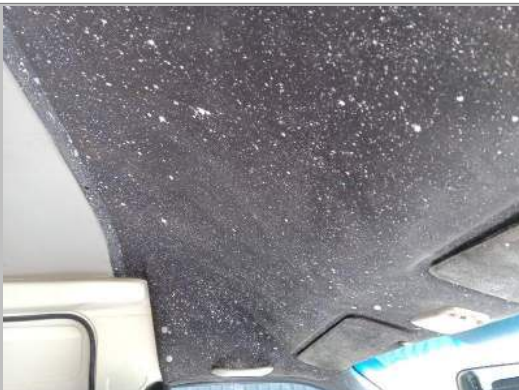
| Hood Lining Damaged | Repair |

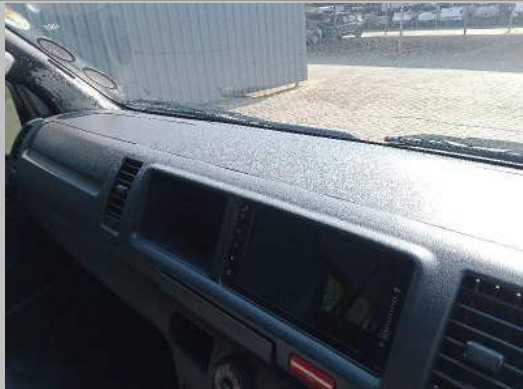
| Dash Padding Damaged | Repair |

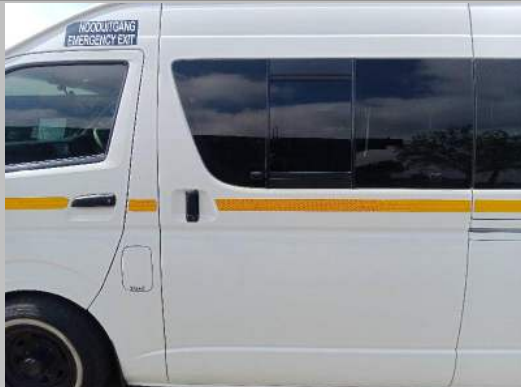
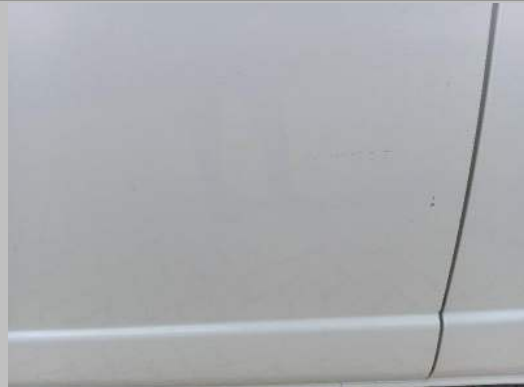
| Door Rear Left Paintwork • Scratched | Repair |

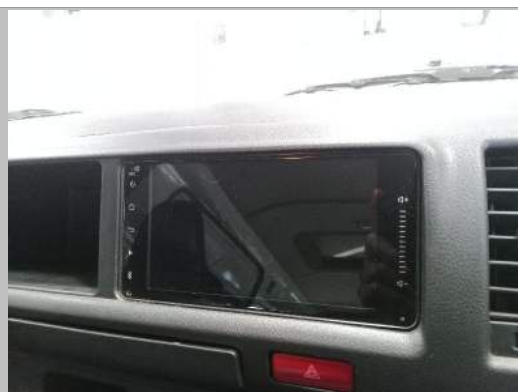
| Radio/CD/USB Defective | Repair |

General Comments: ACCORDING TO THE AGE AND MILEAGE OF THE VEHICLE, NORMAL WEAR AND TEAR MARKS ARE VISIBLE ON THE INTERIOR, EXTERIOR, ELECTRICAL AND MECHANICAL PARTS. Engine Compartment: Alternator pulley welded.  
Electrical Components and Instruments: Radio not working.

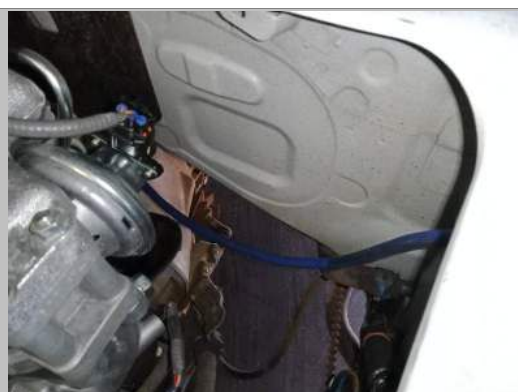
| Engine Wiring Defective | Repair |

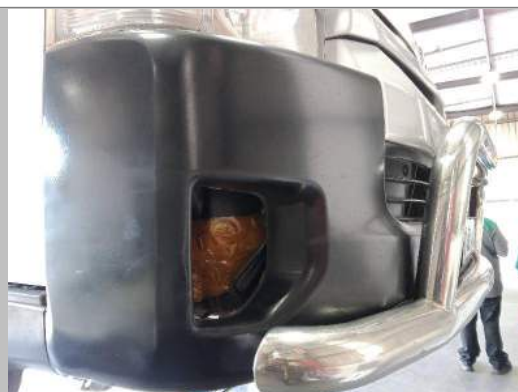
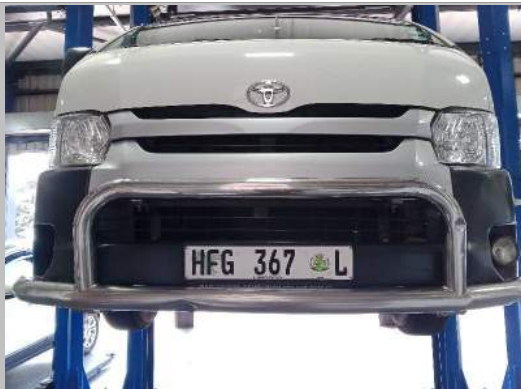
| Front Bumper Damaged | Repair |

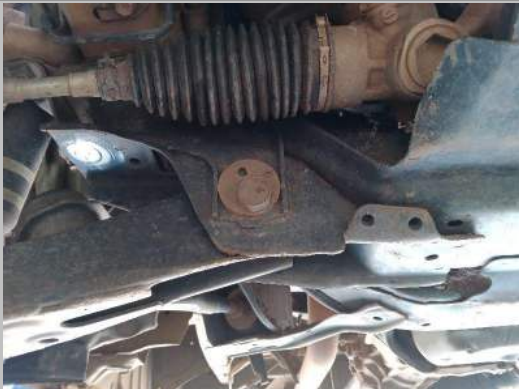
| Sub Frame Damaged | Replace |

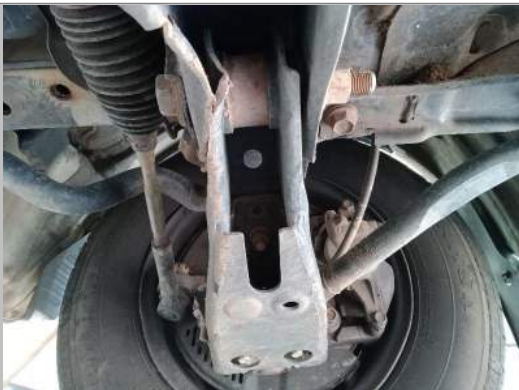
| Control Arm(s) Front Axle Right Damaged | Replace |

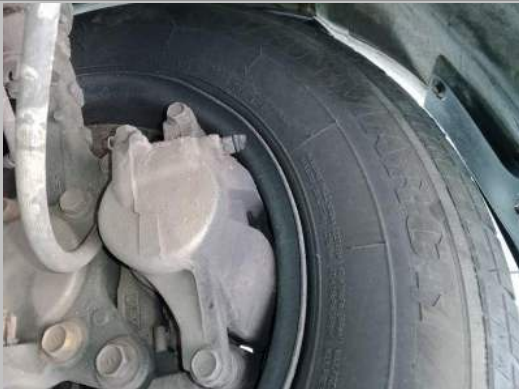
Caliper 1. Axle right

Interior: Vehicle interior dirty and panels scratched. Interior A pillar plastic trims defective. Aftermarket sound fitted to vehicle.  
Body • Exterior: Dents and scratches on body panels. Nudge bar dented.  
Brakes: Front left and right brake calipers grinded down to fit smaller rim. Rear left speed sensor damaged.

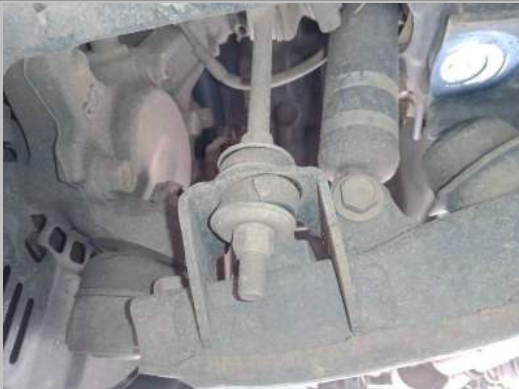
| Stabilizer Mounting Front Right Damaged | Replace |

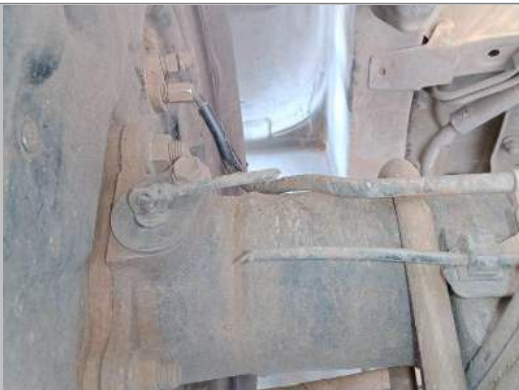
| Speed Sensor Damaged | Replace |

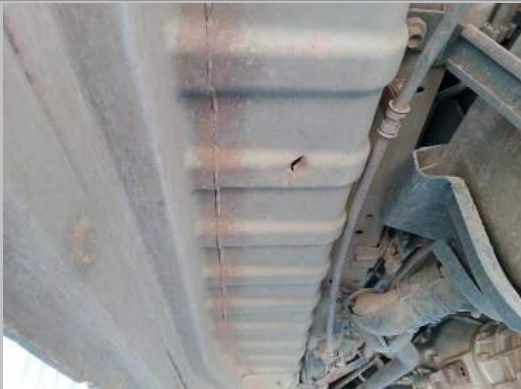
| Chassis Damaged | Repair |
