## CONDITION REPORT

Report No:  
2017298906  
DATE  
15/09/2026

| Manufacturer | HYUNDAI | Registration Number | JD29CMGP |
| Model | ELANTRA MD 1.6 PREMIUM [2011-2015] | Register Number | |

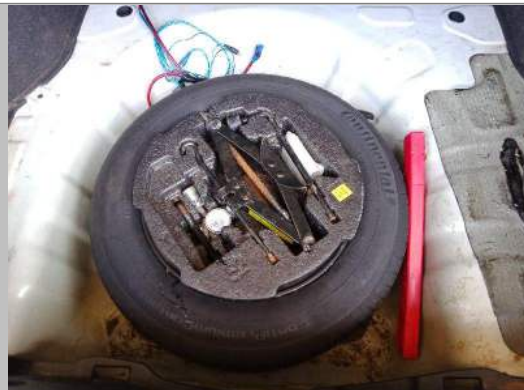
Spare Wheel and Accessories

| Spare Tyre Damaged | Replace |
| Spare Wheel regrooved | Replace |

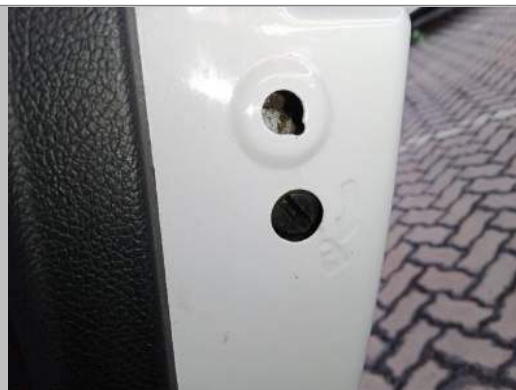
| Damage | Repair Way |
|---|---|
| Rear right door child lock damaged | Replace |

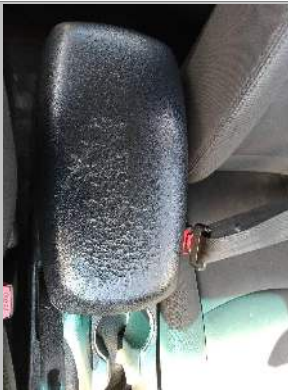
| Center Console / Cubbyhole + Lid Damaged | Repair |

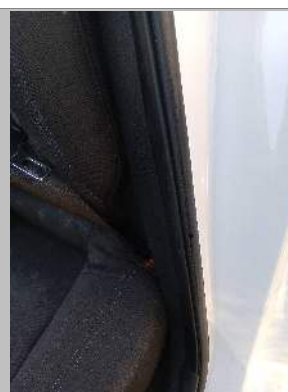
| Door Sealing Rubber Rear Left Damaged | Replace |

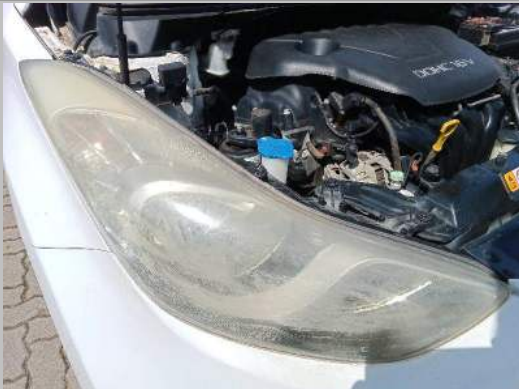
| Headlight Right Damaged | Replace |

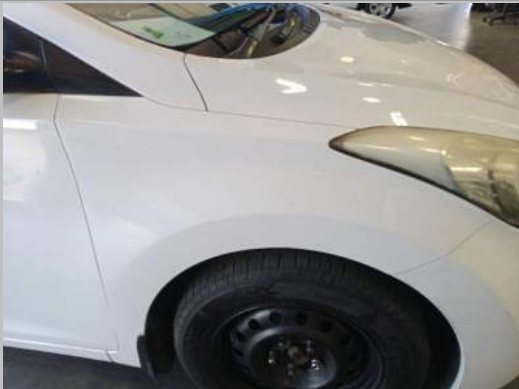
| Front Fender Right Residual Traces of Repair | Repair |

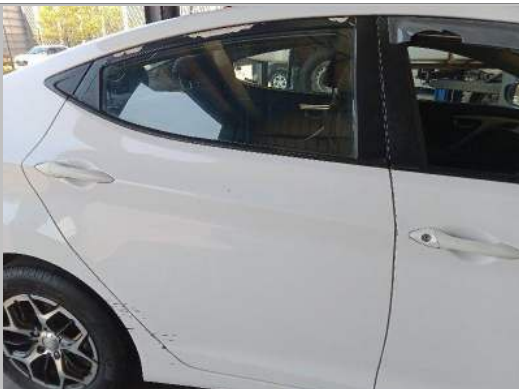
| Door Rear Right Paintwork • Scratched | Repair |

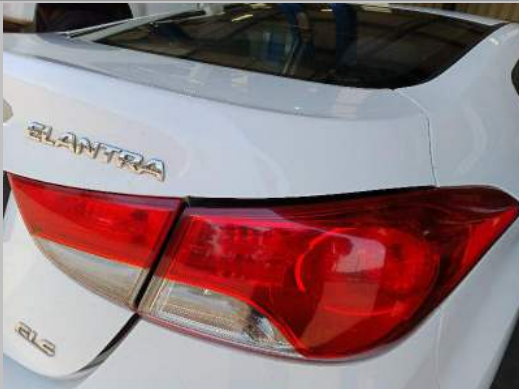
| Tail Light Right Cracked | Replace |

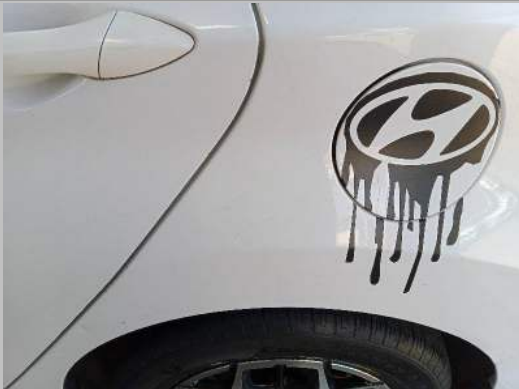
| Rear Fender Left Paintwork • Scratched | Repair |

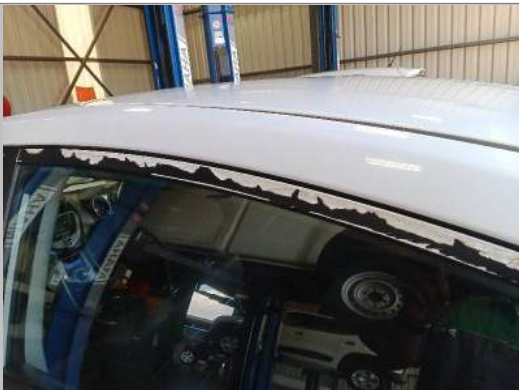
| Weather Strip Door Rear Left Defective | Repair |

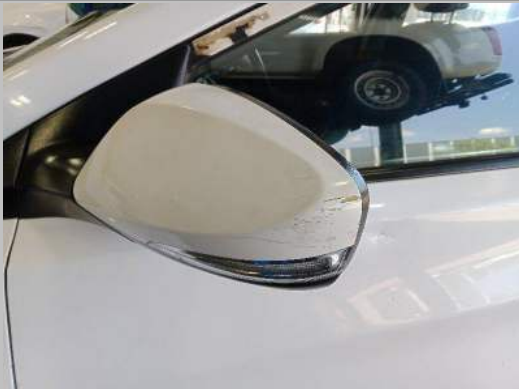
| Side Mirror Left Paintwork • Scratched | Smart Repair |

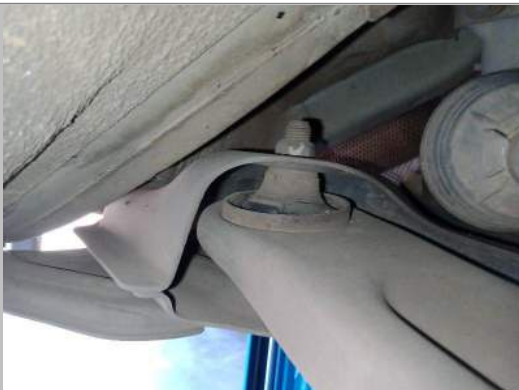
| Control Arm Bush(es) Front Axle Right Cracked | Replace |

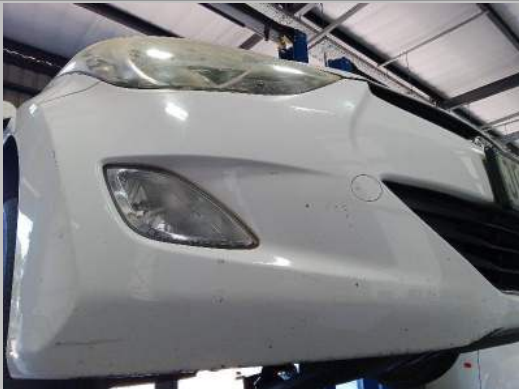
| Front Bumper Paintwork • Scratched | Repair |

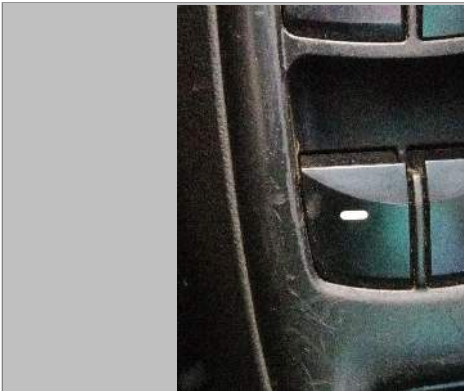
| Switch Electrical Window Winder rear left Damaged | Replace |
