## CONDITION REPORT

Report No:  
2017299367  
DATE  
16/09/2026

| Manufacturer | FORD | Registration Number | KTC025NW |
| Model | ECOSPORT 1.5 AMBIENTE [2016-2018] | Register Number | |

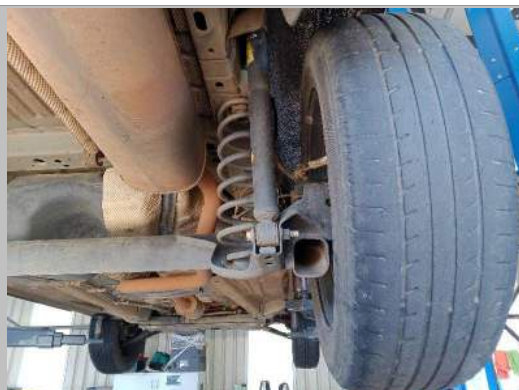
RR TYRE TREAD

| Damage | Repair Way |
|---|---|
| Tyre Rear Right Worn | Replace |

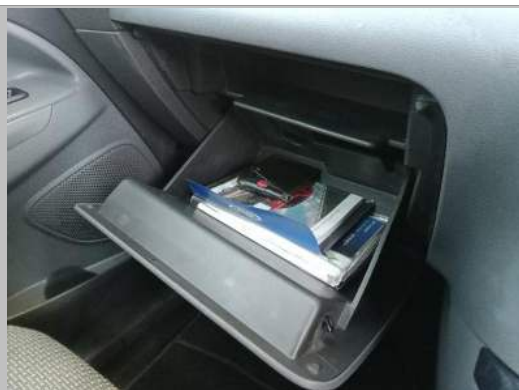
| Damage | Repair Way |
|---|---|
| Center Console / Cubbyhole + Lid Damaged | Repair |

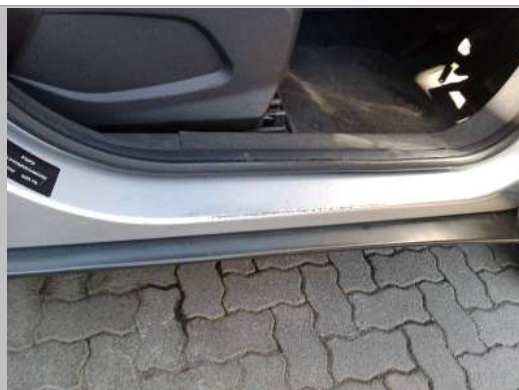
| Damage | Repair Way |
|---|---|
| Sill Panel Right Damaged | Repair |

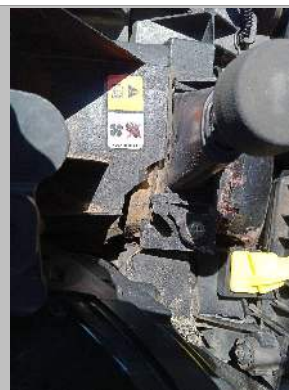
| Damage | Repair Way |
|---|---|
| Bonnet slam plate (Shock tower/ Inner tray) Damaged | Replace |

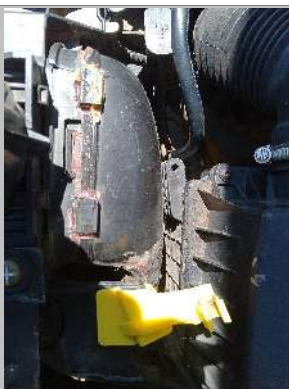
| Damage | Repair Way |
|---|---|
| Air cleaner Damaged | Replace |

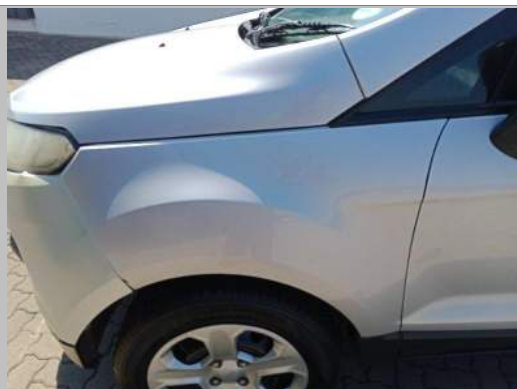
| Damage | Repair Way |
|---|---|
| Front Fender Left Damaged | Repair |

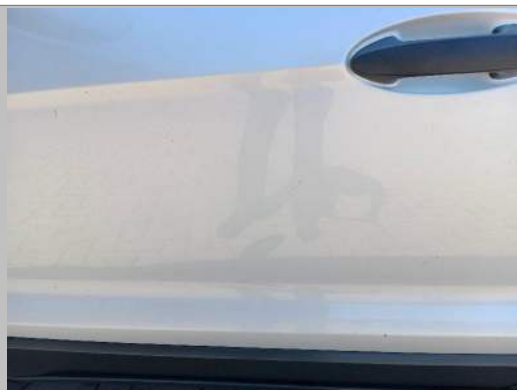
| Damage | Repair Way |
|---|---|
| Door Front Left Paintwork • Chipmarks | Repair |

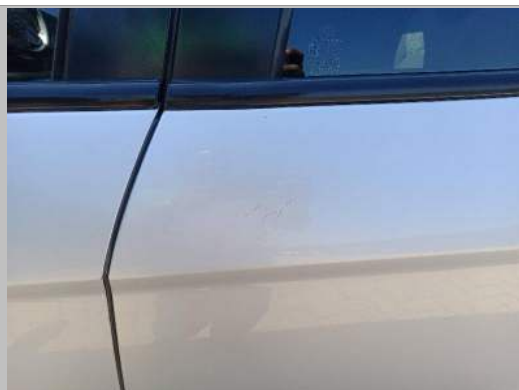
| Damage | Repair Way |
|---|---|
| Door Rear Left Paintwork • Scratched | Repair |

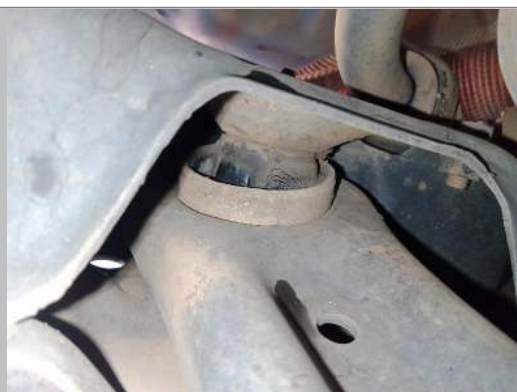
| Damage | Repair Way |
|---|---|
| Control Arm Bush(es) Front Axle Right Cracked | Replace |

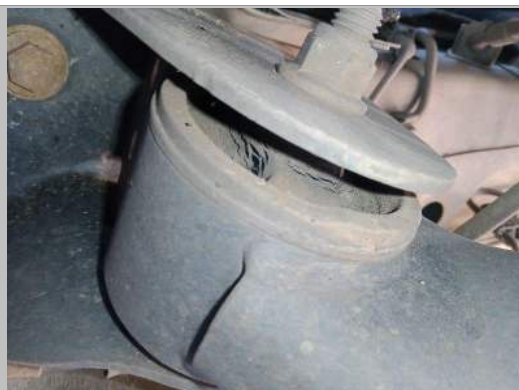
| Damage | Repair Way |
|---|---|
| Mounting Rubber(s) Rear Axle Left Cracked | Replace |
