CONDITION REPORT

Report No:  
2017297476  
DATE  
11/09/2026

| Manufacturer | HYUNDAI | Registration Number | JL97JSGP |
| Model | ATOS 1.1 50KW MOTION 5-DR [2019-2024] | Register Number | |

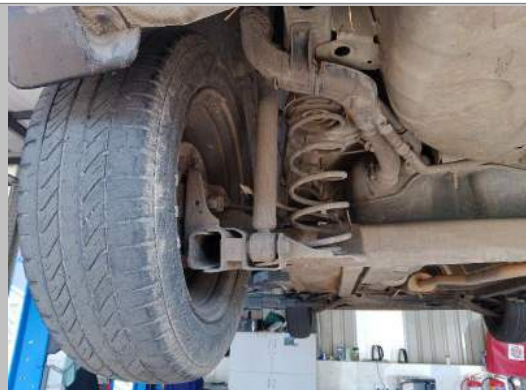
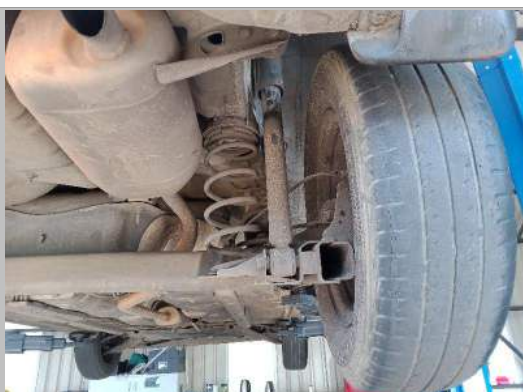
LR TYRE TREAD

| Damage | Repair Way |
|---|---|
| Tyre Rear Left Worn | Replace |
| Tyre Rear Right Worn | Replace |

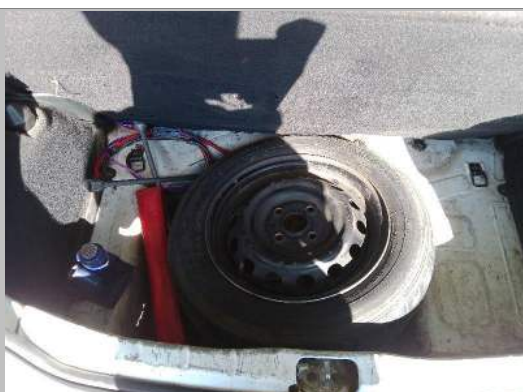
Spare Wheel and Accessories

| Damage | Repair Way |
|---|---|
| Spare Tyre Damaged | Replace |

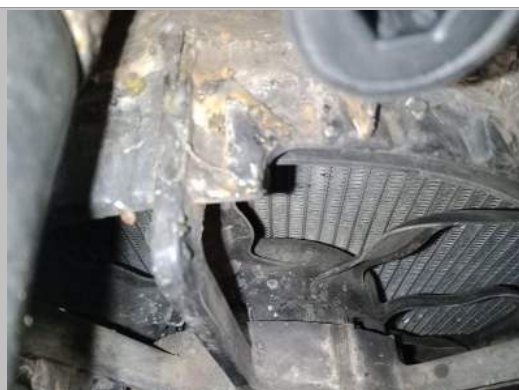
| Fan Cowley damaged | Replace |

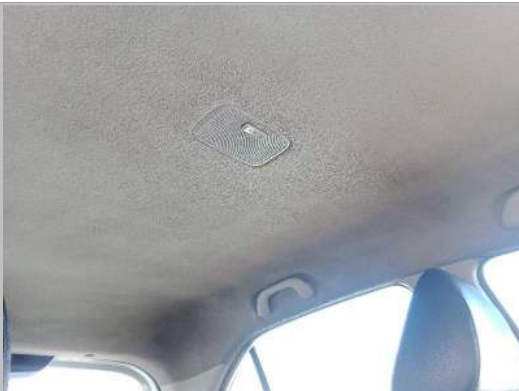
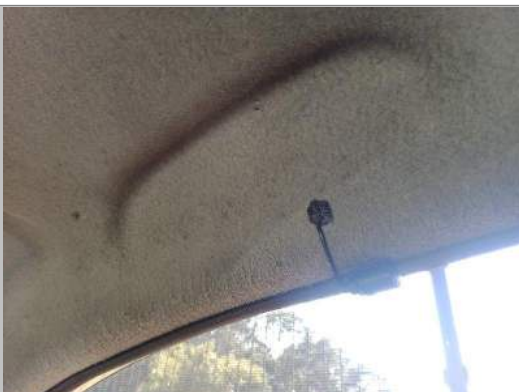
| Damage | Repair Way |
|---|---|
| Hood Lining Damaged | Repair |

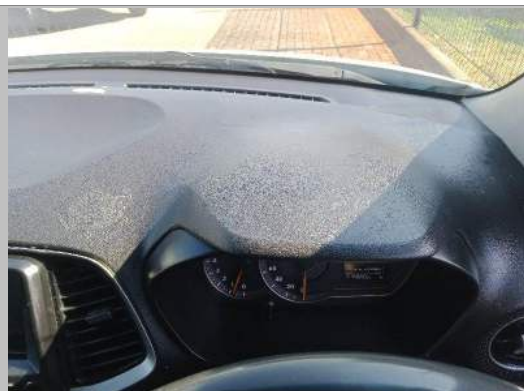
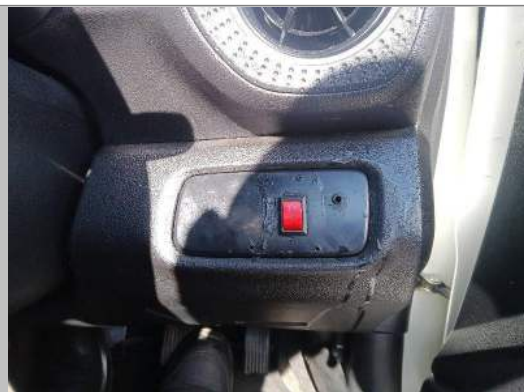
| Damage | Repair Way |
|---|---|
| Dash Padding Damaged | Repair |

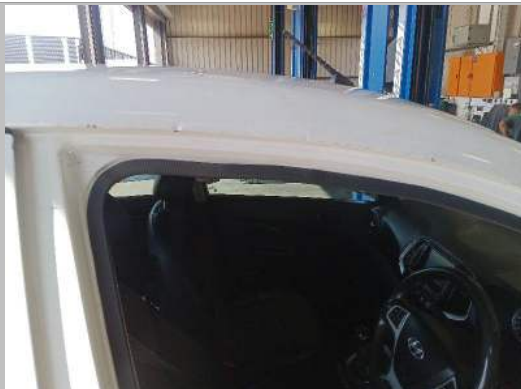
| Damage | Repair Way |
|---|---|
| B • Pillar Right Damaged | Repair |

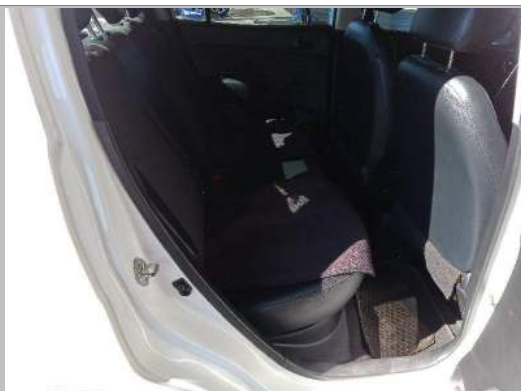
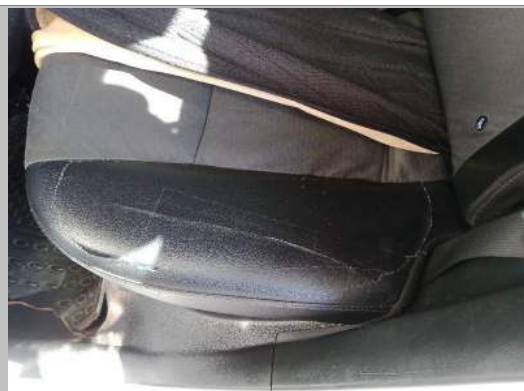
| Damage | Repair Way |
|---|---|
| Seat Rear Damaged | Repair |

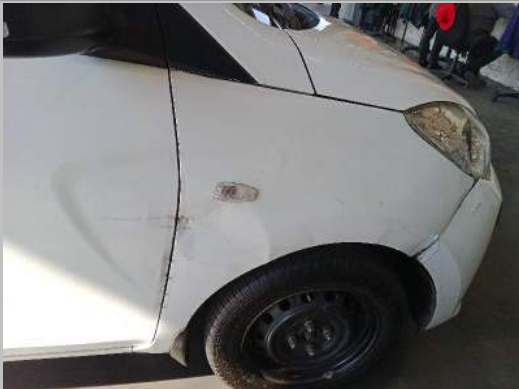
| Damage | Repair Way |
|---|---|
| Front Fender Right Damaged | Repair |

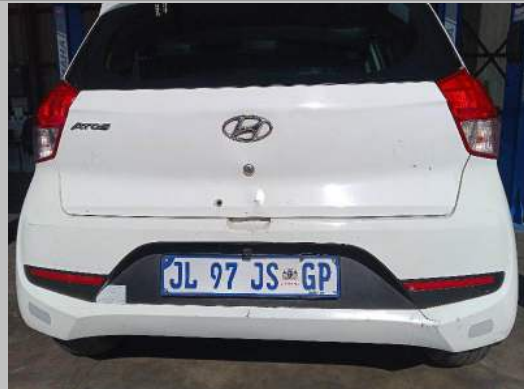
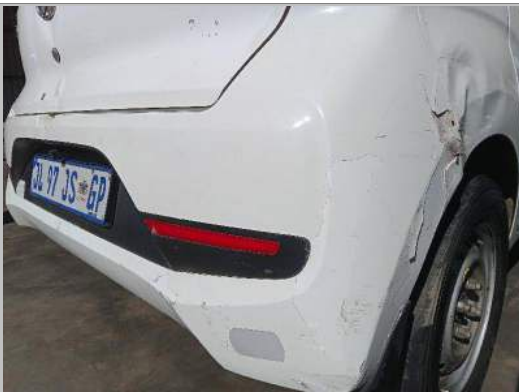
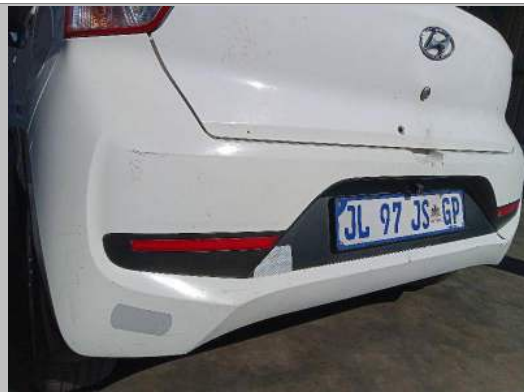
| Damage | Repair Way |
|---|---|
| Rear bumper Damaged | Replace |

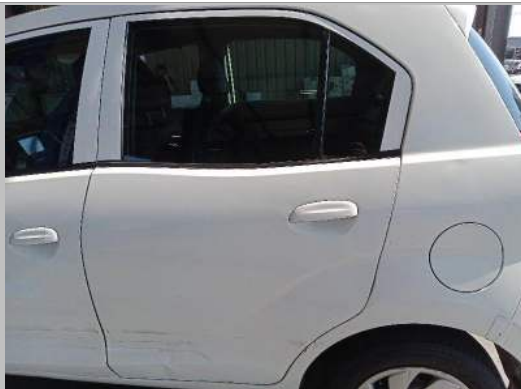
| Damage | Repair Way |
|---|---|
| Door Rear Left Damaged | Repair |

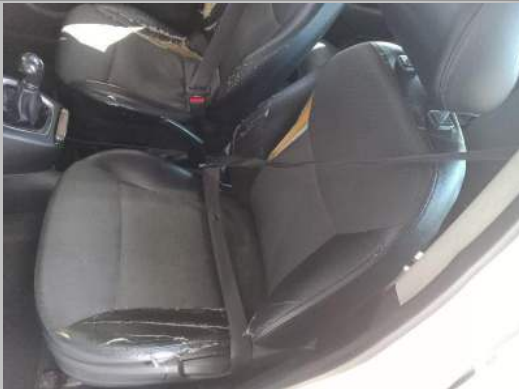
| Damage | Repair Way |
|---|---|
| Seat Front Left Damaged | Repair |

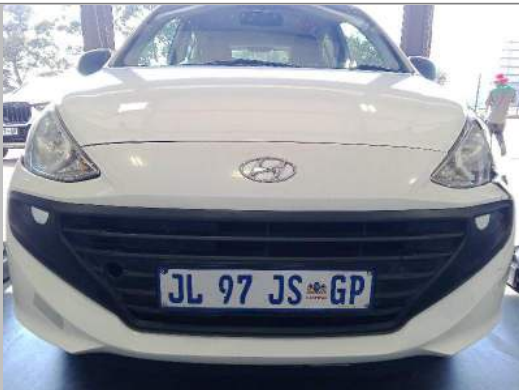
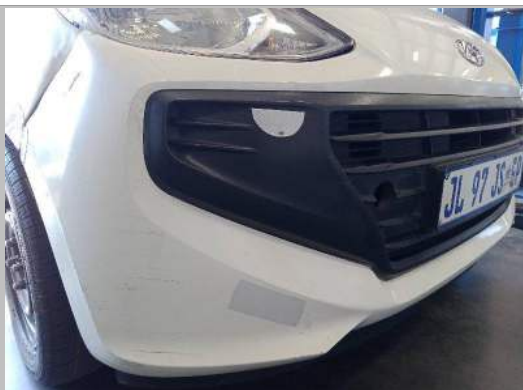
| Damage | Repair Way |
|---|---|
| Front Bumper Damaged | Replace |

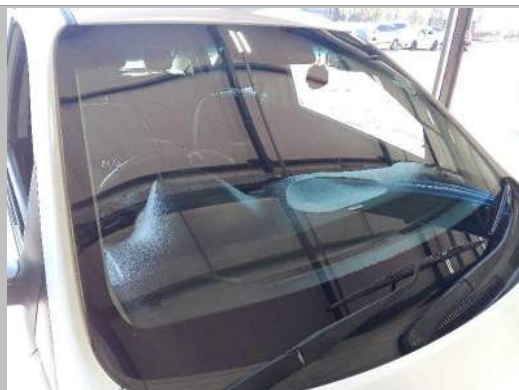
| Damage | Repair Way |
|---|---|
| Windscreen Cracked | Replace |

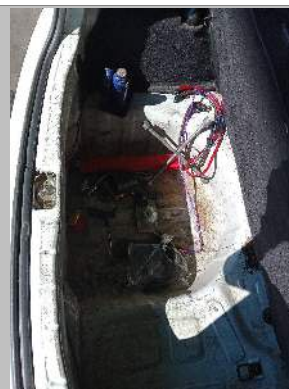
| Damage | Repair Way |
|---|---|
| Inner Boot Floor Pan and Spare Wheel Well Damaged | Repair |

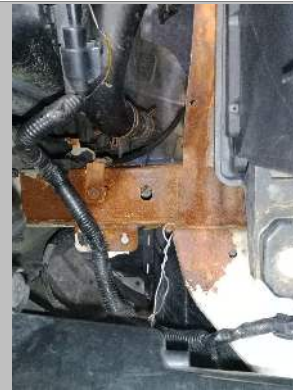
| Damage | Repair Way |
|---|---|
| Main Beam Left Damaged | Repair |

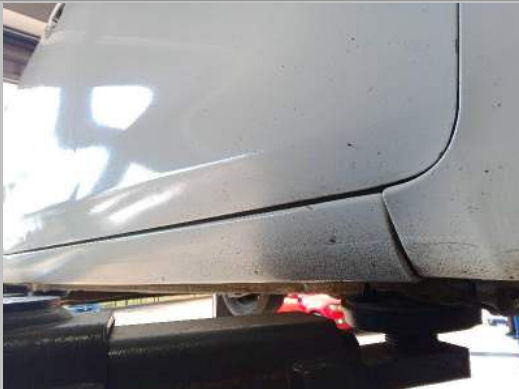
| Damage | Repair Way |
|---|---|
| Sill Panel Right Damaged | Repair |

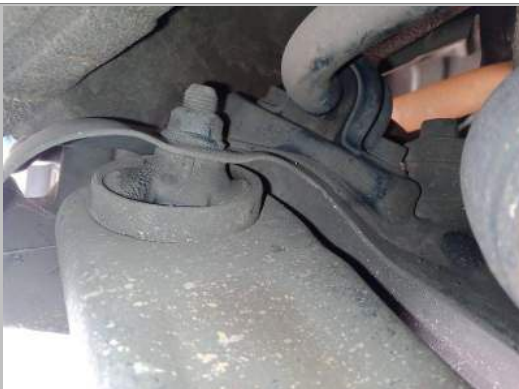
| Damage | Repair Way |
|---|---|
| Control Arm Bush(es) Front Axle Right Cracked | Replace |

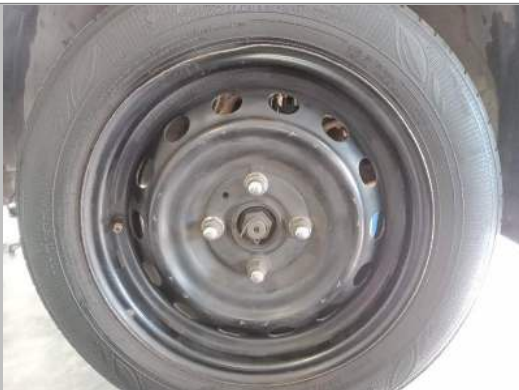
| Damage | Repair Way |
|---|---|
| Rim Front Left Dented | Repair |

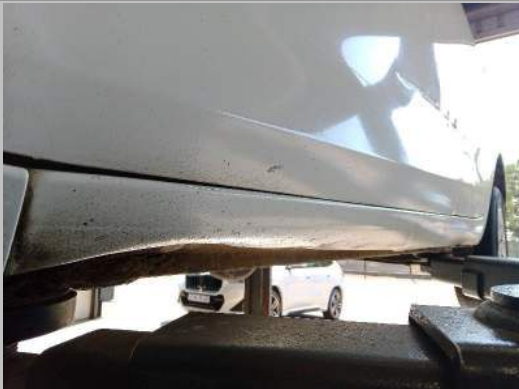
| Damage | Repair Way |
|---|---|
| Sill Panel Left Damaged | Repair |

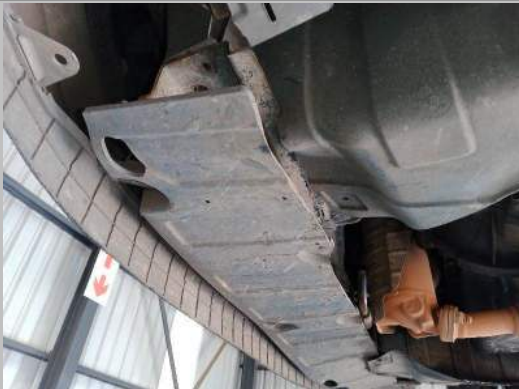
| Belly plates Damaged | Repair |

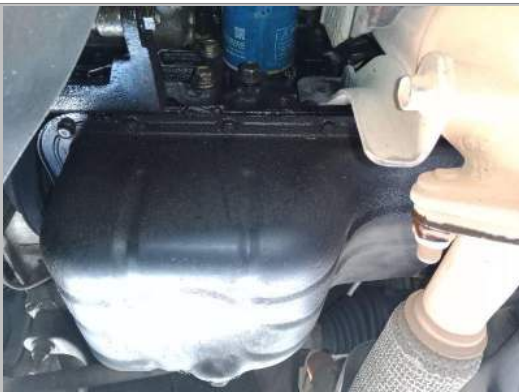
| Engine Performance Idling / Hunting | Repair |
| Engine Noise Excessive | Repair |

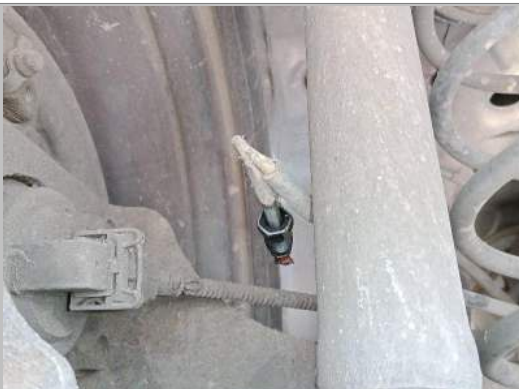
| Damage | Repair Way |
|---|---|
| Brake Piping Damaged | Replace |

Brakes: Rear left brake piping damaged.
