## CONDITION REPORT

Report No:  
2017299411  
DATE  
16/09/2026

| Manufacturer | HYUNDAI | Registration Number | LS68RZGP |
| Model | GRAND I10 | Register Number | |

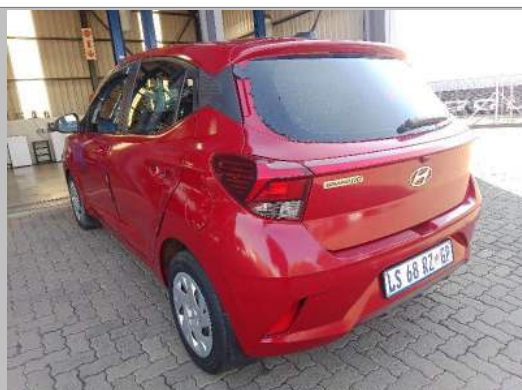
REAR LEFT CORNER

| Damage | Repair Way |
|---|---|
| Tail Light Left Damaged | Replace |

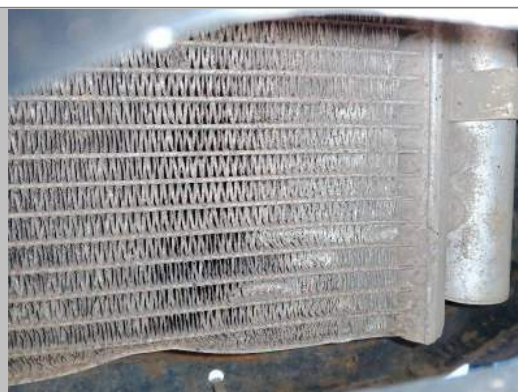
| Damage | Repair Way |
|---|---|
| Aircon condenser damaged | Replace |

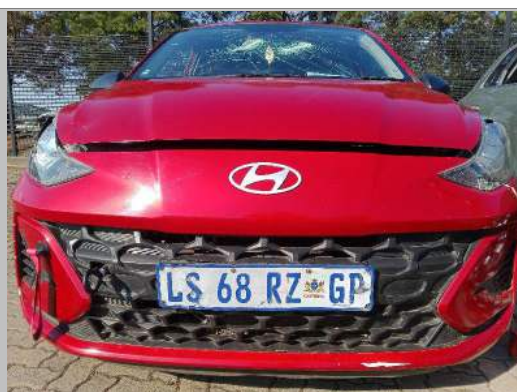
| Damage | Repair Way |
|---|---|
| Front Bumper Damaged | Replace |

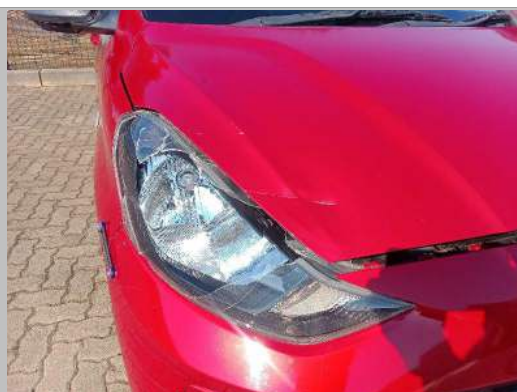
| Damage | Repair Way |
|---|---|
| Headlight Right Damaged | Replace |

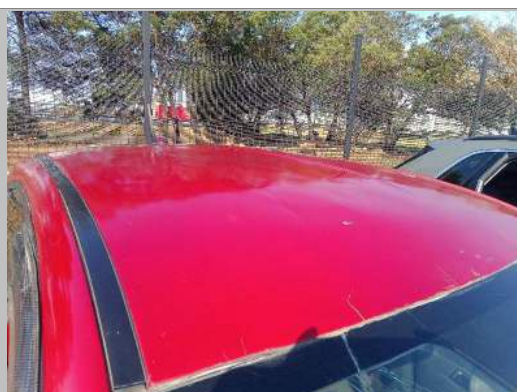
| Damage | Repair Way |
|---|---|
| Roof Residual Traces of Repair | Repair |

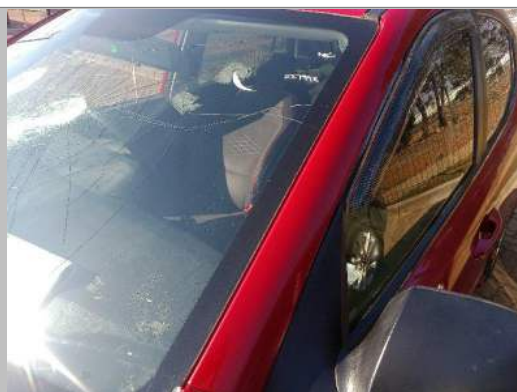
| Damage | Repair Way |
|---|---|
| A • Pillar Left Residual Traces of Repair | Repair |

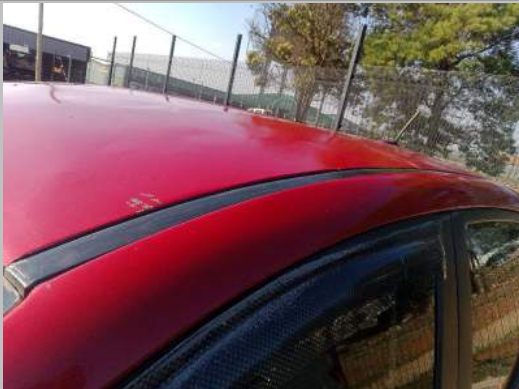
| Damage | Repair Way |
|---|---|
| B • Pillar Left Residual Traces of Repair | Repair |

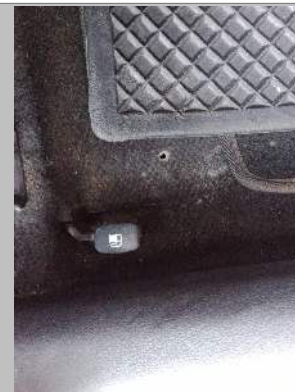
| Damage | Repair Way |
|---|---|
| Carpet Front Damaged | Repair |

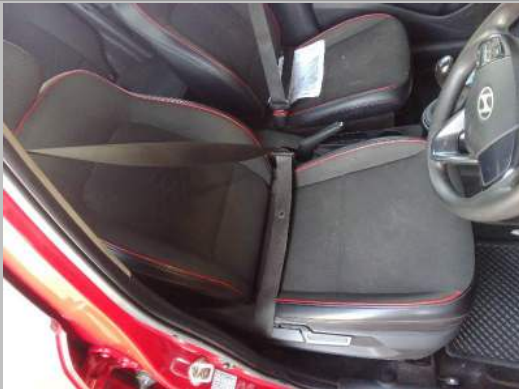
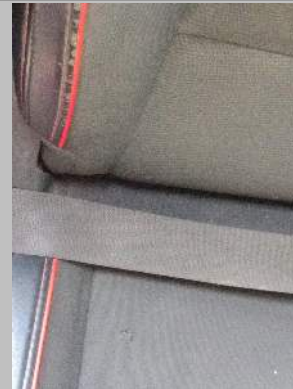
| Damage | Repair Way |
|---|---|
| Seat Front Right Damaged | Repair |

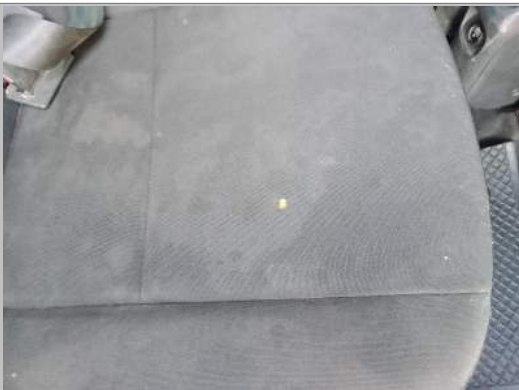
| Damage | Repair Way |
|---|---|
| Seat Rear Damaged | Repair |

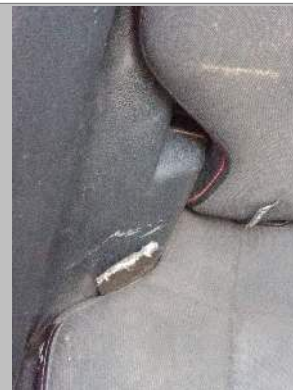
| Damage | Repair Way |
|---|---|
| Seat Belt Rear Right Damaged | Replace |

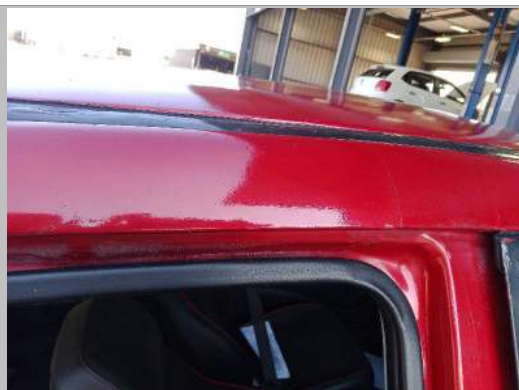
| Damage | Repair Way |
|---|---|
| B • Pillar Right Residual Traces of Repair | Repair |

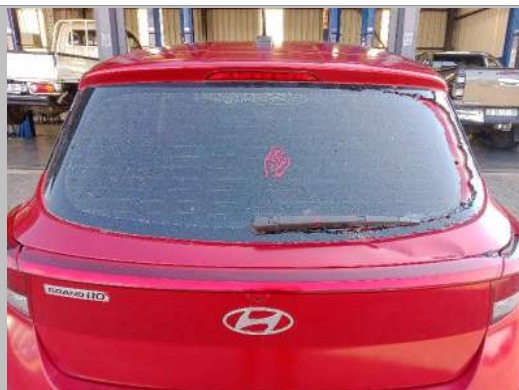
| Damage | Repair Way |
|---|---|
| Boot Lid / Hatch door Damaged | Replace |

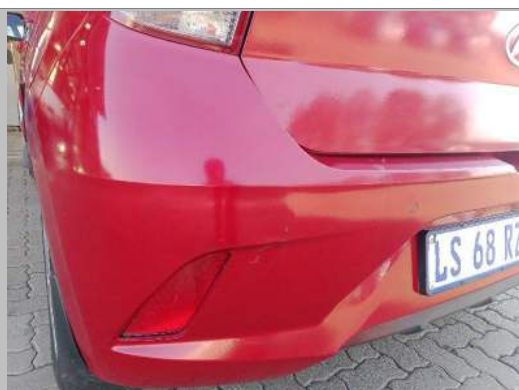
| Damage | Repair Way |
|---|---|
| Rear bumper Residual Traces of Repair | Repair |

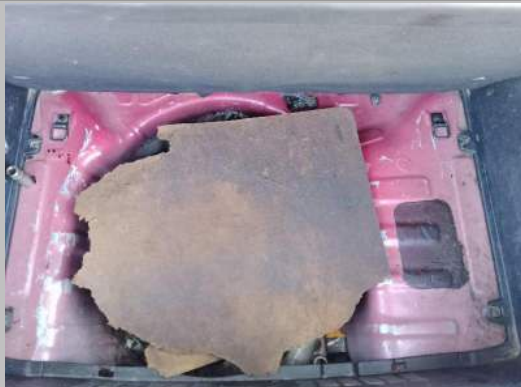
| Damage | Repair Way |
|---|---|
| Inner Boot Floor Pan and Spare Wheel Well Paintwork • Scratched | Repair |

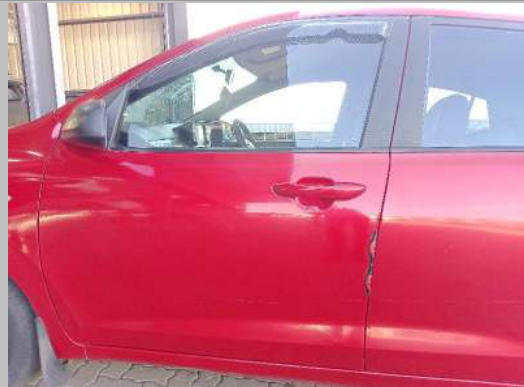
| Damage | Repair Way |
|---|---|
| Door Front Left Residual Traces of Repair | Repair |

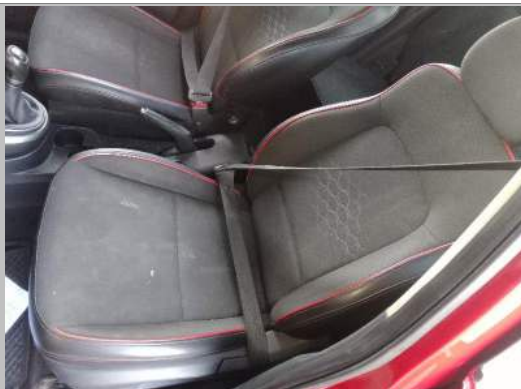
| Damage | Repair Way |
|---|---|
| Seat Front Left Damaged | Repair |

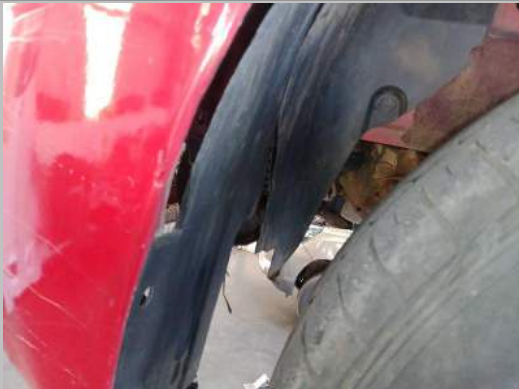
| Damage | Repair Way |
|---|---|
| Front Fender Left / Inner Tray Damaged | Replace |

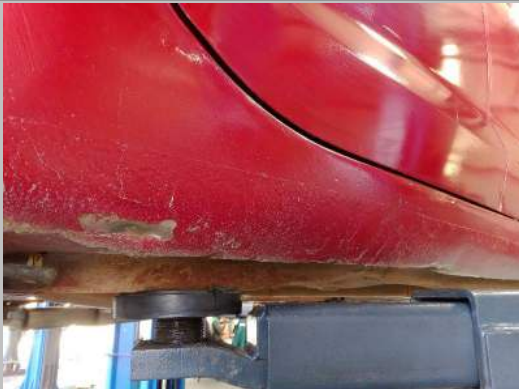
| Damage | Repair Way |
|---|---|
| Sill Panel Right Damaged | Repair |

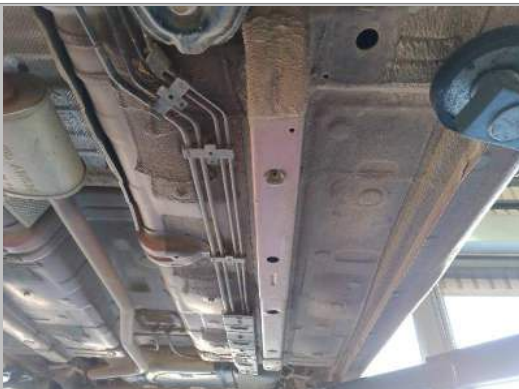
| Damage | Repair Way |
|---|---|
| Chassis Damaged | Repair |
