CONDITION REPORT

Report No:  
2017295665  
DATE  
08/09/2026

| Manufacturer | RENAULT | Registration Number | KD84XHGP |
| Model | KWID | Register Number | |

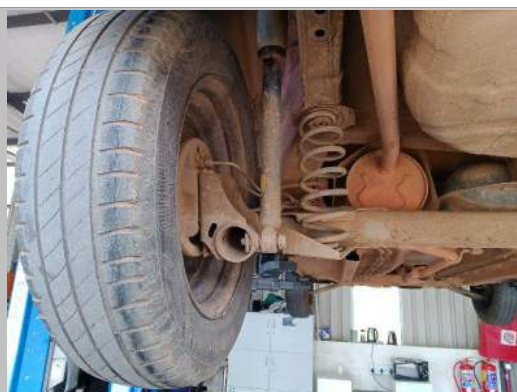
LR TYRE TREAD

| Tyre Rear Left Damaged | Replace |

| Damage | Repair Way |
|---|---|
| Rear left tyre regrooved | Replace |

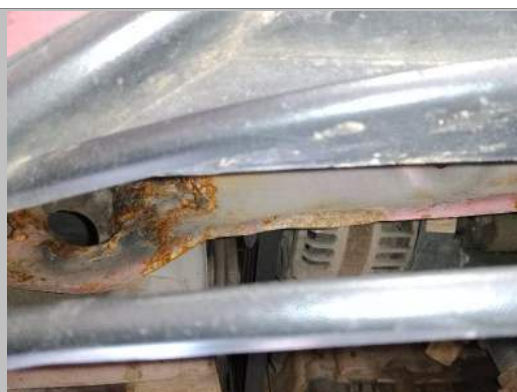
| Damage | Repair Way |
|---|---|
| Front bumper stiffener damaged | Replace |

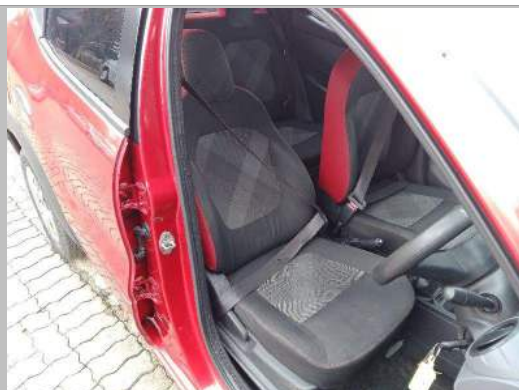
| Seat Front Right Dirty | Repair |

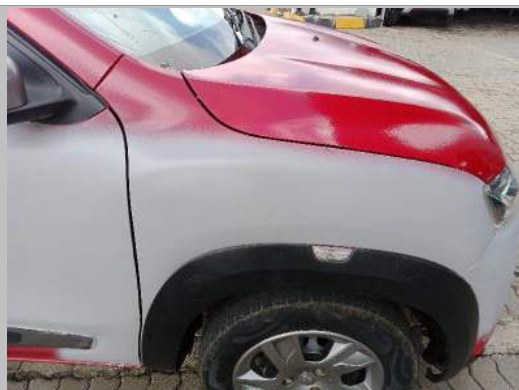
| Front Fender Right Residual Traces of Repair | Repair |

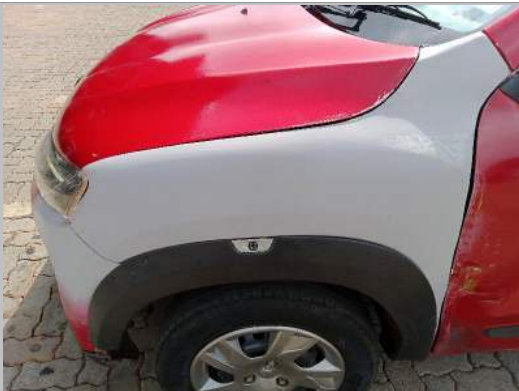
| Front Fender Left Residual Traces of Repair | Repair |

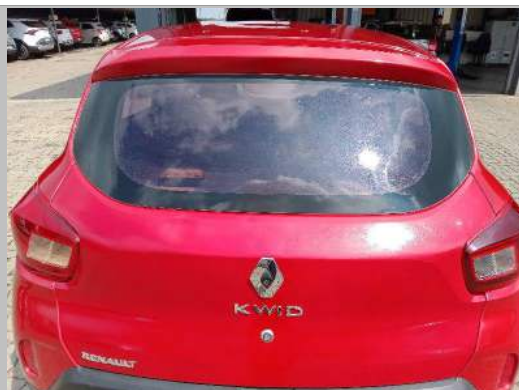
| Boot Lid / Hatch door Damaged | Repair |

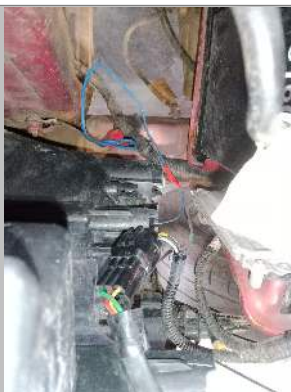
| Engine Wiring Defective | Replace |

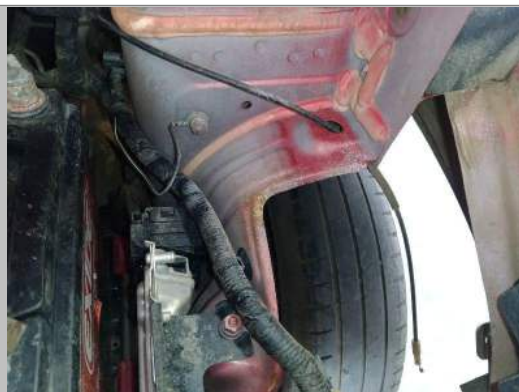
| Front Fender Left / Inner Tray Damaged | Repair |

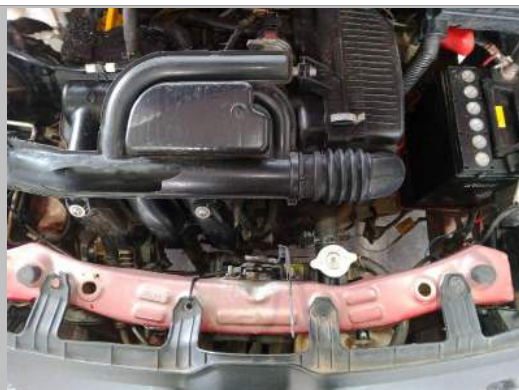
| Bonnet slam plate (Shock tower/ Inner tray) Damaged | Repair |

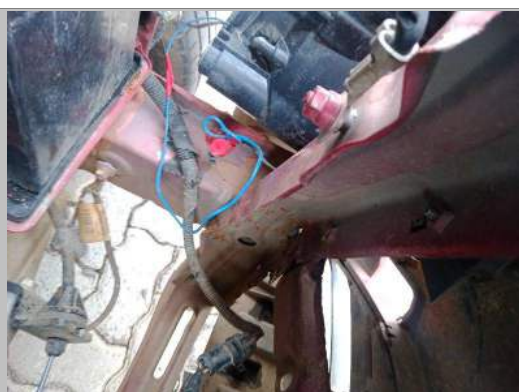
| Damage | Repair Way |
|---|---|
| Radiator Cradle Damaged | Replace |

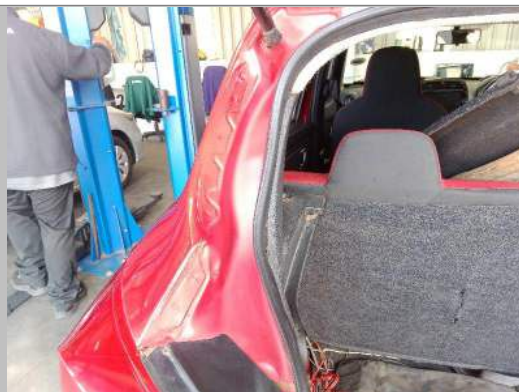
| C • Pillar Left Residual Traces of Repair | Repair |

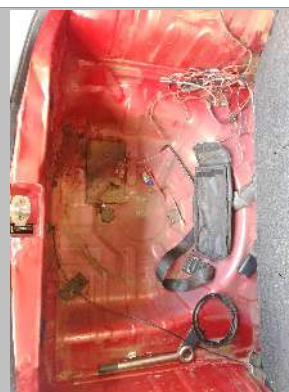
| Rear Fender Left / Inner Tray Damaged | Repair |

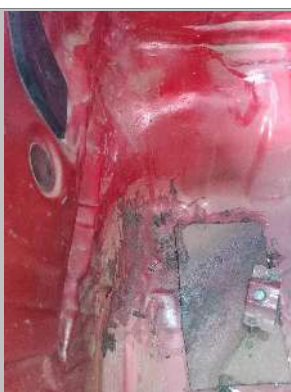
| Inner Boot Floor Pan and Spare Wheel Well Damaged | Repair |

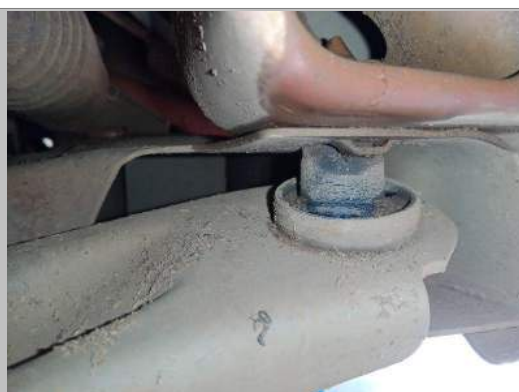
| Control Arm Bush(es) Front Axle Right Cracked | Replace |

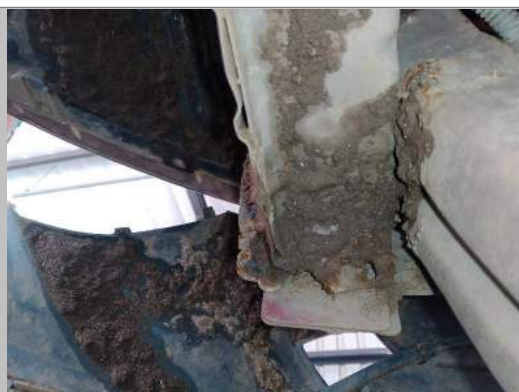
| Main Beam Left Damaged | Repair |

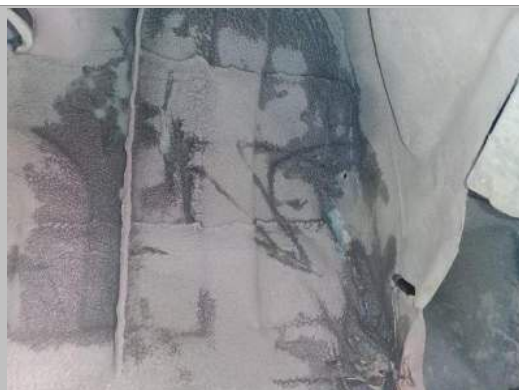
| Sill Panel Left Damaged | Repair |

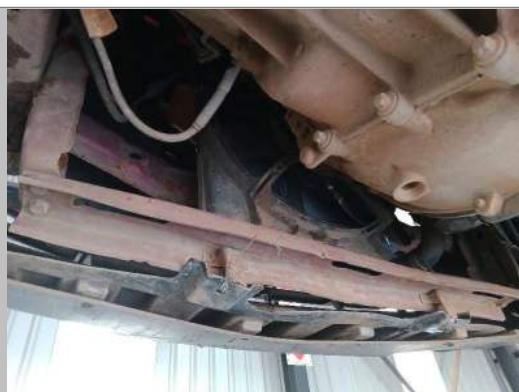
| Sill Panel Right Damaged | Repair |

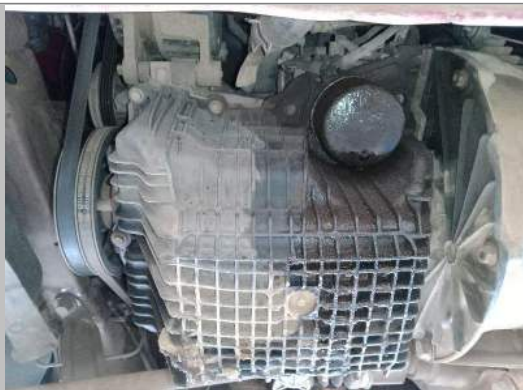
| Damage | Repair Way |
|---|---|
| Gearbox Mountings Cracked | Replace |
