## CONDITION REPORT

2017293640

| Manufacturer | RENAULT | Registration Number | LG18WRGP |
| Model | TRIBES | Register Number | |

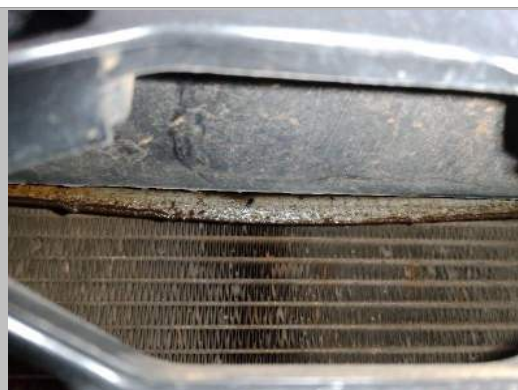
| Damage | Repair Way |
|---|---|
| Front bumper stiffener dented | Repair |

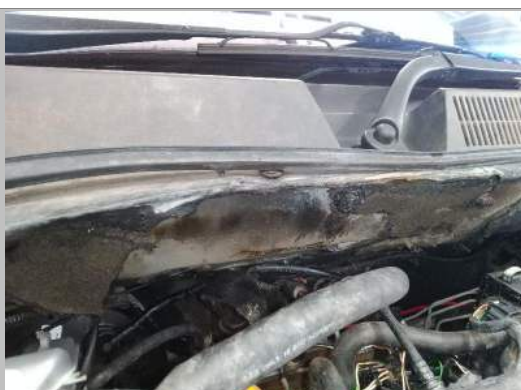
| Damage | Repair Way |
|---|---|
| Firewall insulation cover damaged | Replace |

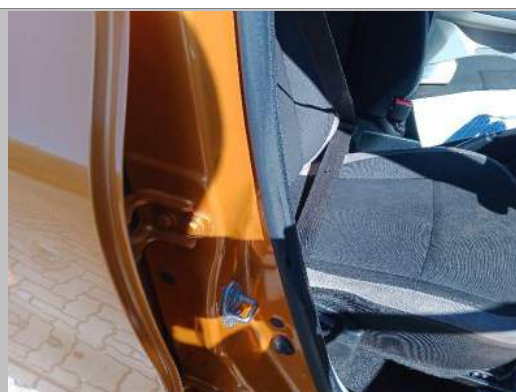
| Damage | Repair Way |
|---|---|
| Door Sealing Rubber Front Right Damaged | Replace |

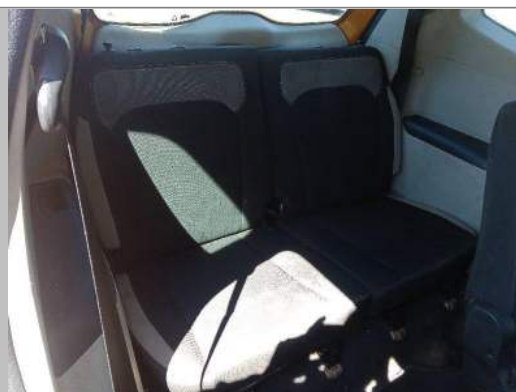
| Damage | Repair Way |
|---|---|
| Seat Rear ( 2. Row) Dirty | Repair |

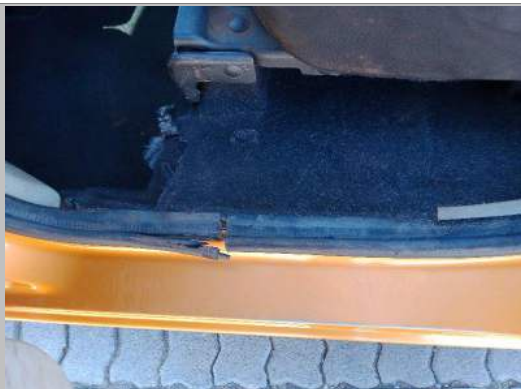
| Damage | Repair Way |
|---|---|
| Door Sealing Rubber Rear Left Damaged | Replace |

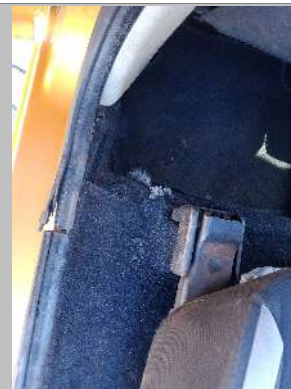
| Damage | Repair Way |
|---|---|
| Carpet Rear Damaged | Repair |

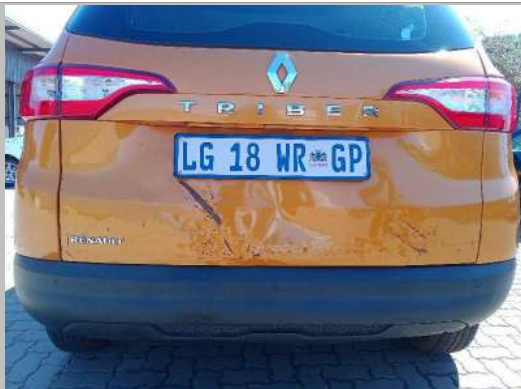
| Damage | Repair Way |
|---|---|
| Rear bumper Damaged | Repair |

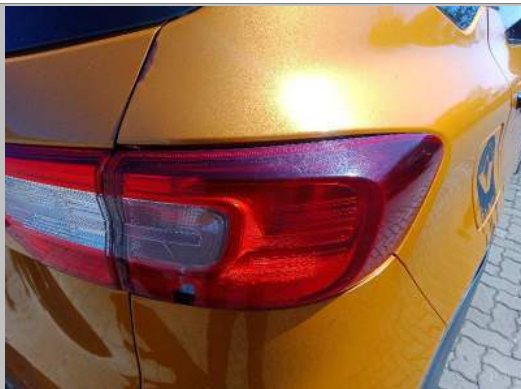
| Damage | Repair Way |
|---|---|
| Tail Light Right Damaged | Replace |

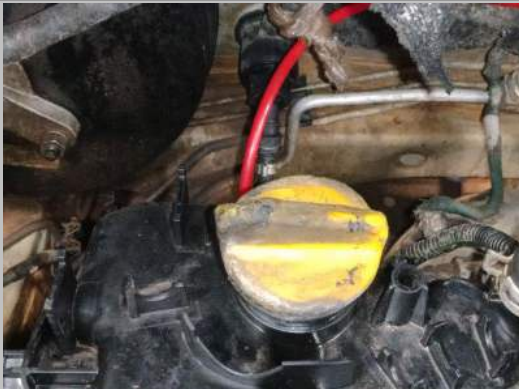
| Damage | Repair Way |
|---|---|
| Caps Damaged | Replace |

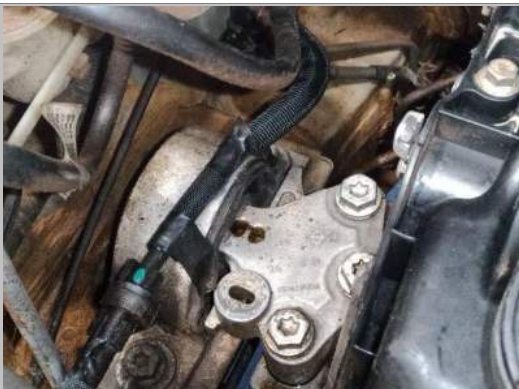
| Damage | Repair Way |
|---|---|
| Engine mountings Damaged | Replace |

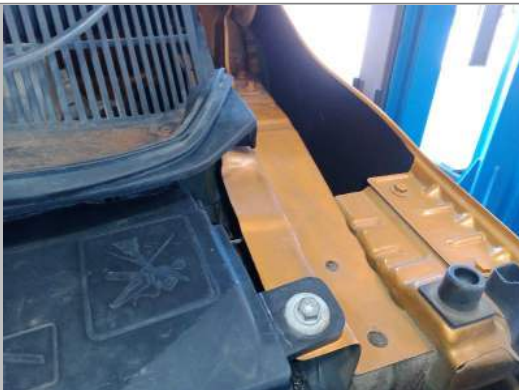
| Damage | Repair Way |
|---|---|
| Front Fender Left / Inner Tray Dented | Repair |

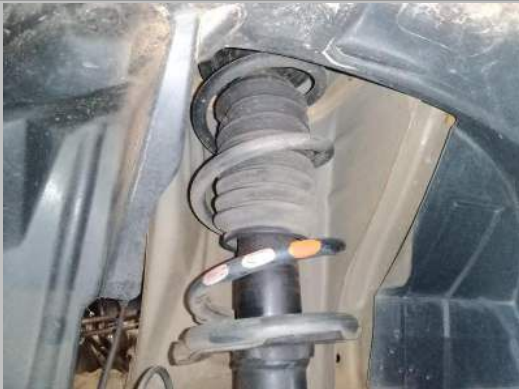
| Damage | Repair Way |
|---|---|
| Shock Absorber Front Right Sweat | Replace |
| Front right shock absorber weak | Replace |

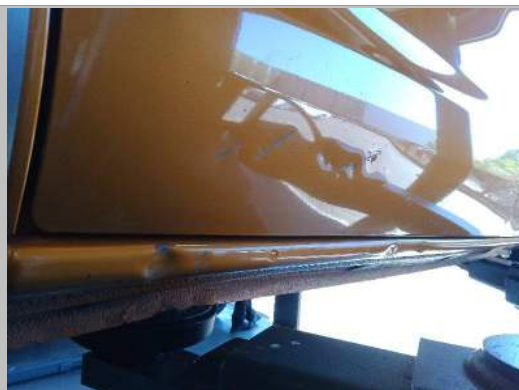
| Damage | Repair Way |
|---|---|
| Sill Panel Left Damaged | Repair |

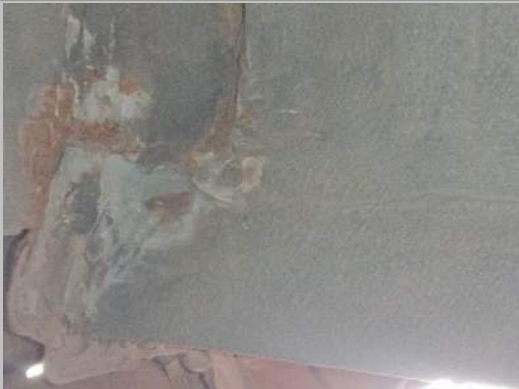
| Damage | Repair Way |
|---|---|
| Main Beam Right Damaged | Repair |

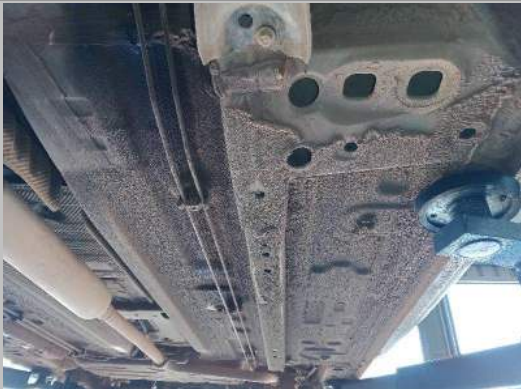
| Damage | Repair Way |
|---|---|
| Chassis Dented | Repair |

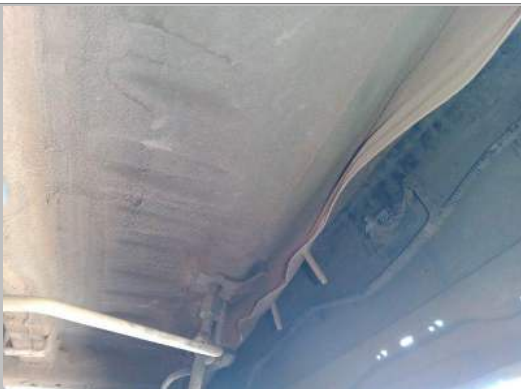
| Damage | Repair Way |
|---|---|
| Inner Boot Floor Pan and Spare Wheel Well Damaged | Repair |

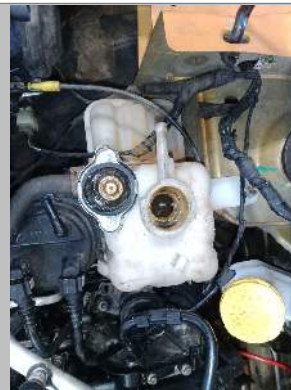
Water level

| Damage | Repair Way |
|---|---|
| Expansion Bottle Water Leak | Replace |

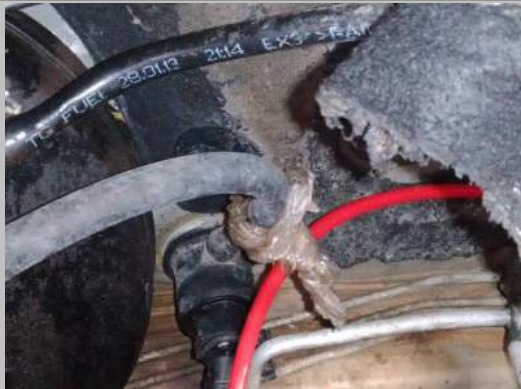
| Damage | Repair Way |
|---|---|
| Hoses Defective | Replace |
