## CONDITION REPORT

Report No:  
2017294297  
DATE  
04/09/2026

| Manufacturer | NISSAN | Registration Number | JZP592EC |
| Model | NAVARA 2.3 LE D-CAB DSL 4X4 PU [2017-2019] | Register Number | |

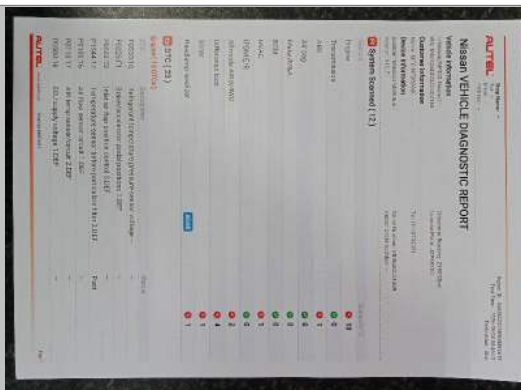
Diagnostic report page 1

During the diagnostic the following error messages were detected: (See also attached Diagnostic Report. For more information regarding the Fault Codes (DTC) and the recommended rectifications please contact the workshops of the vehicle manufacture).

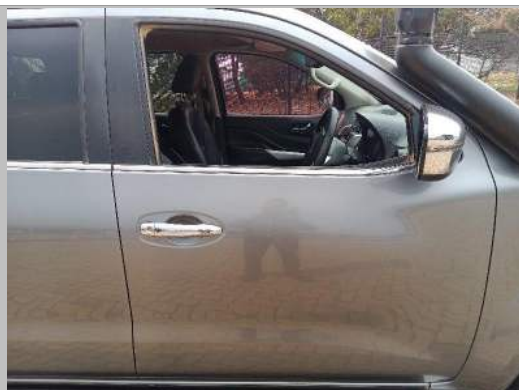
| Damage | Repair Way |
|---|---|
| Door Front Right Paintwork • Scratched | Repair |

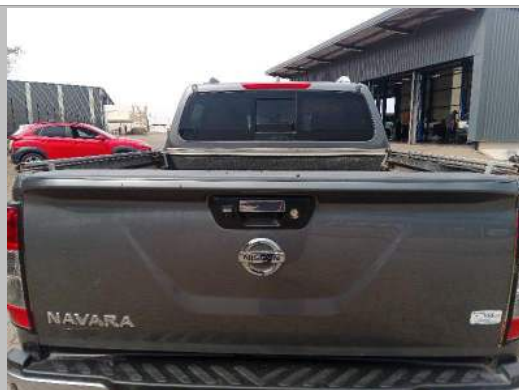
| Damage | Repair Way |
|---|---|
| Tailgate Damaged | Repair |

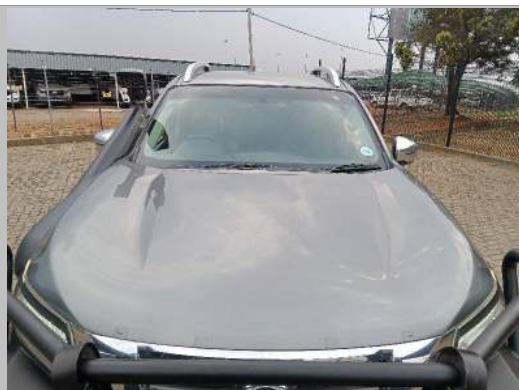
| Damage | Repair Way |
|---|---|
| Bonnet Damaged | Repair |

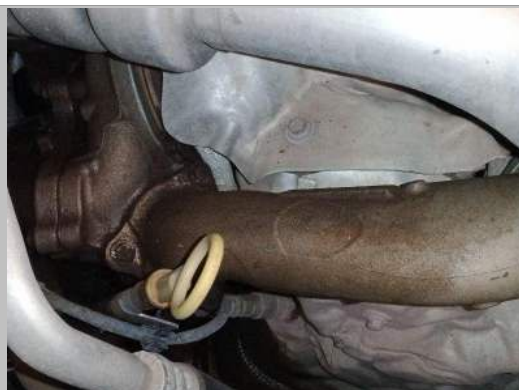
| Damage | Repair Way |
|---|---|
| Hoses Oil Leak | Replace |

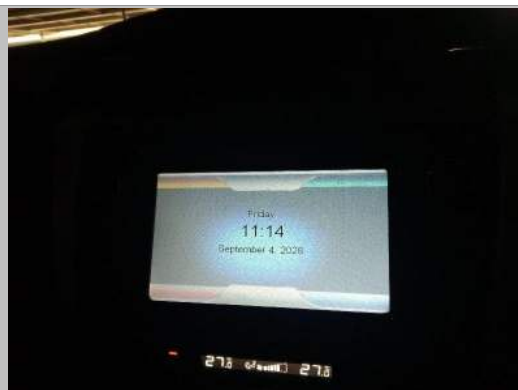
| Damage | Repair Way |
|---|---|
| Radio/CD/USB Damaged | Repair |
